Subject: Request for Qualifications for Professional Design Services - CLARIFICATION & ADDITIONAL INFO REQUEST

EXISTING BUILDING EVALUATION

BUILDING NEEDS ASSESSMENT

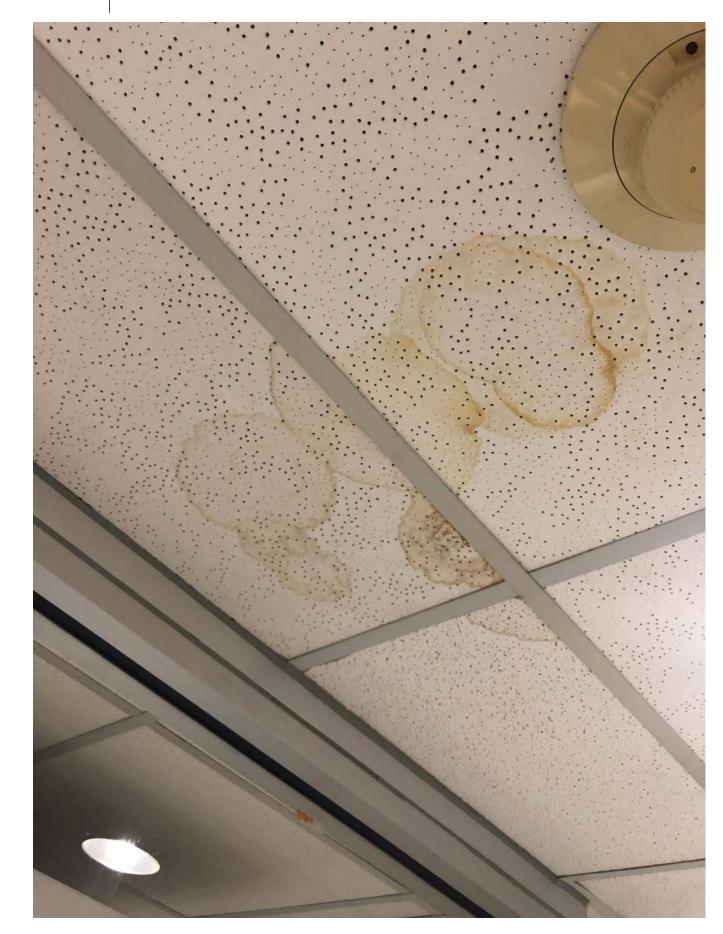
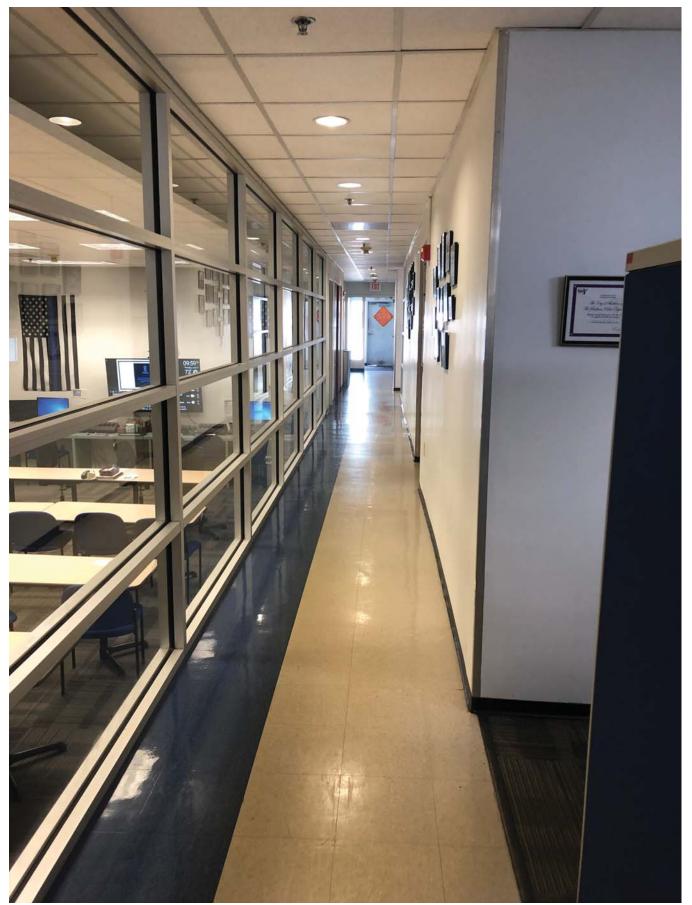
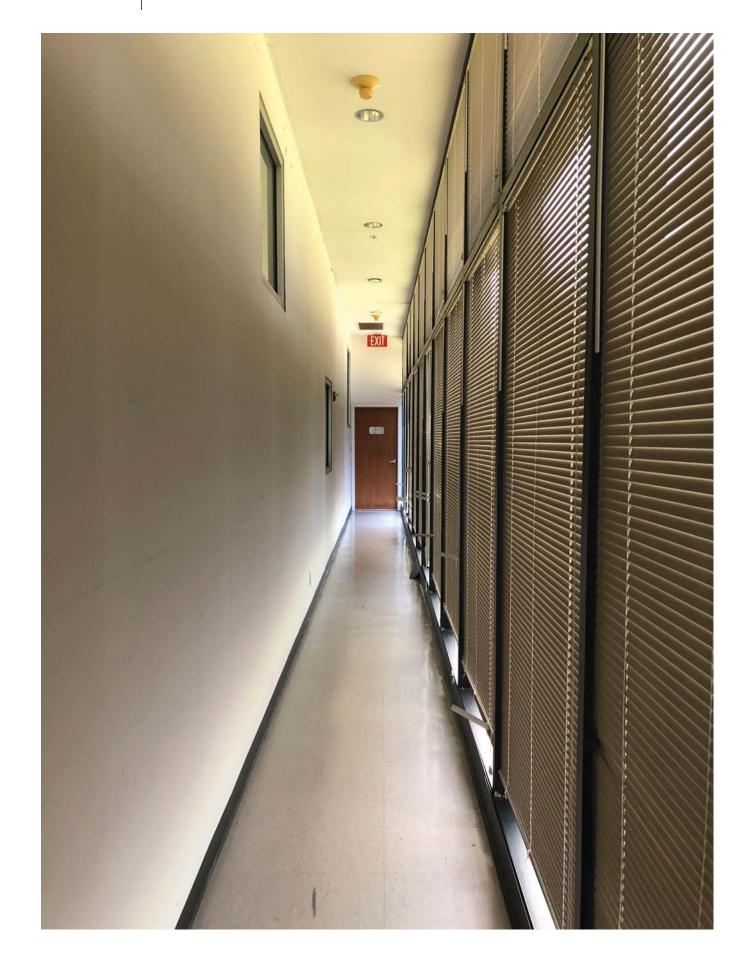
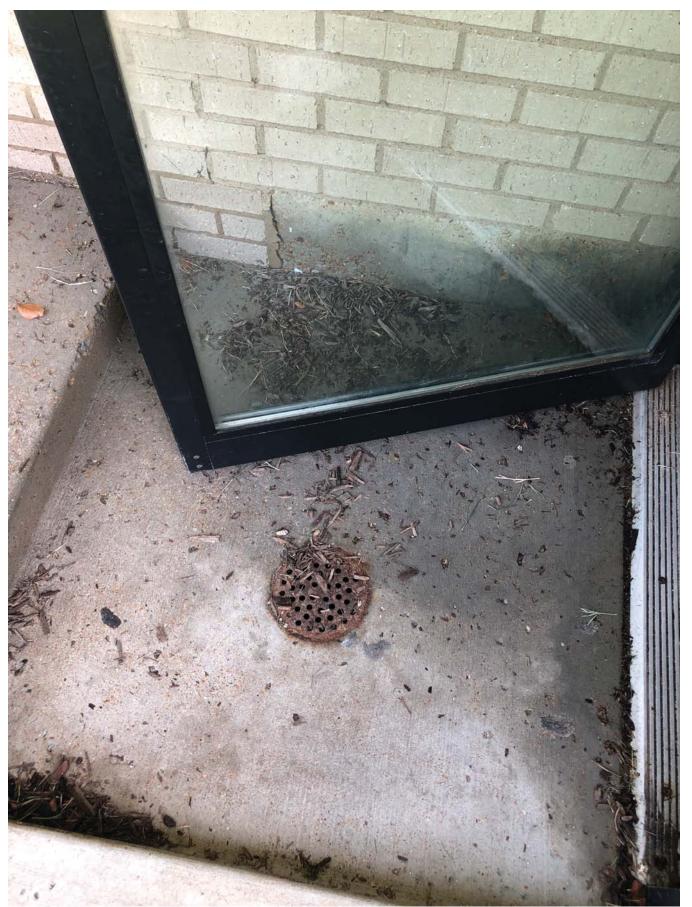
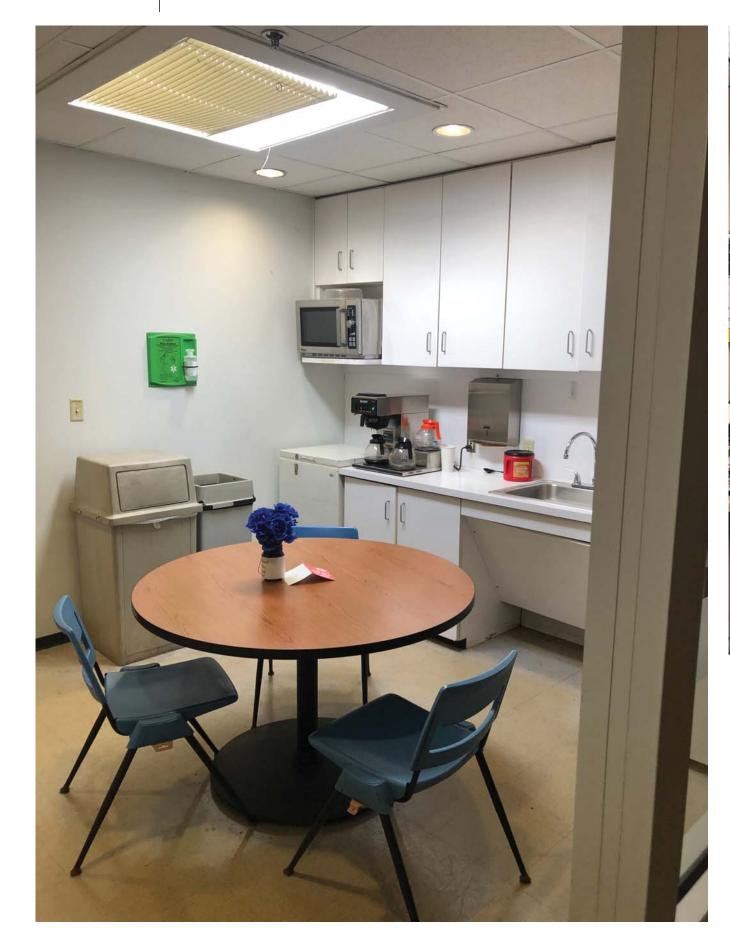
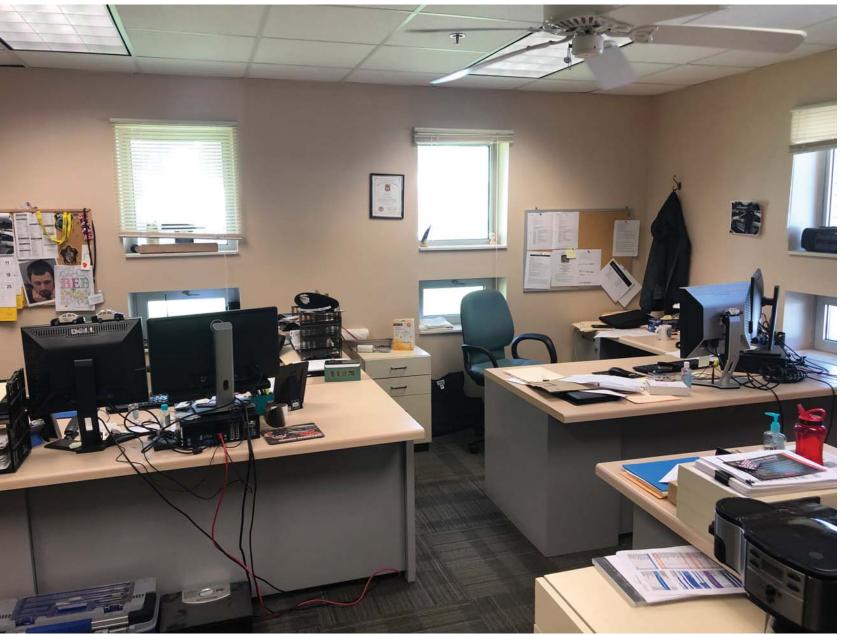
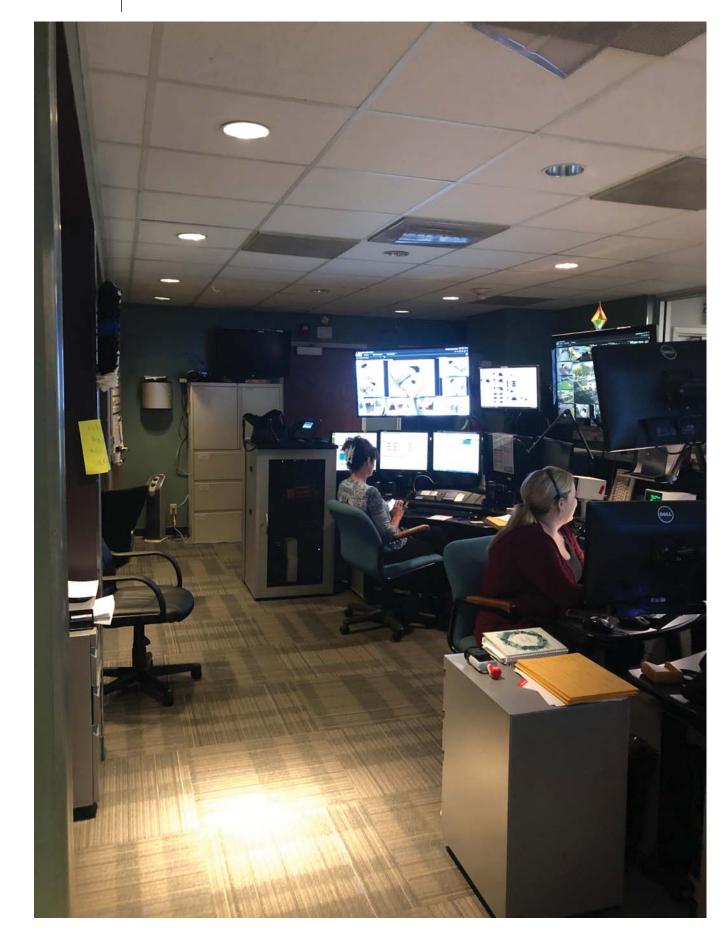
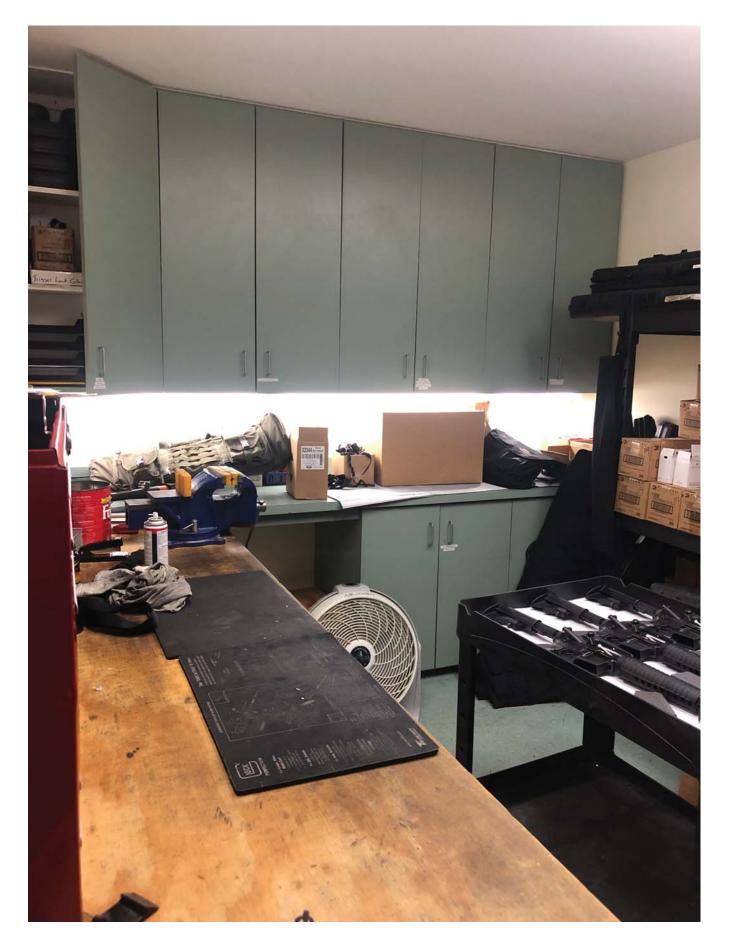
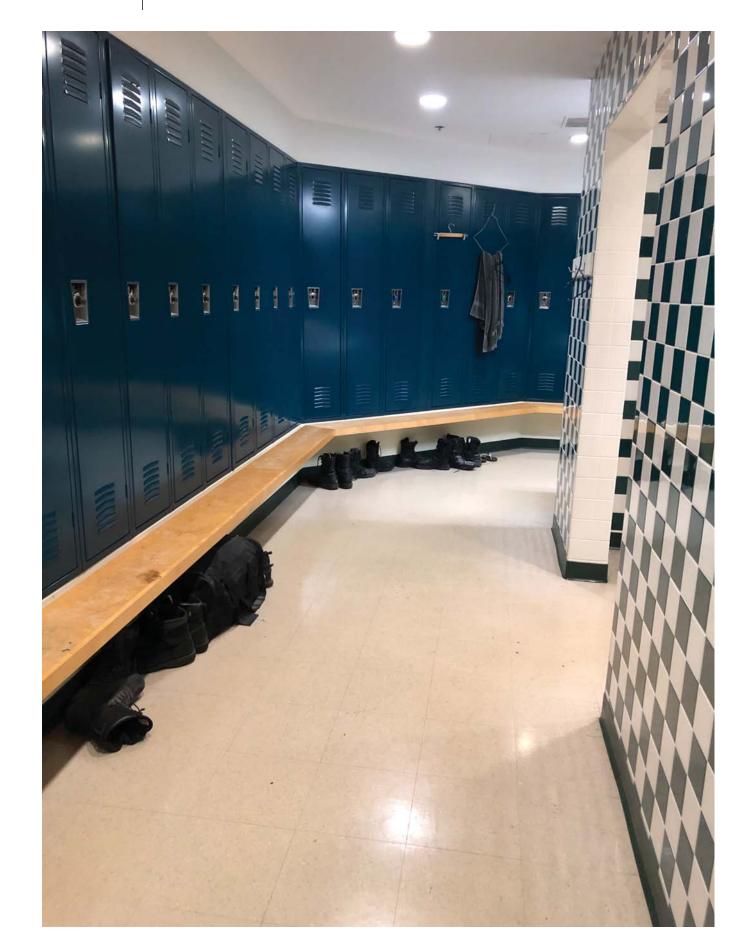
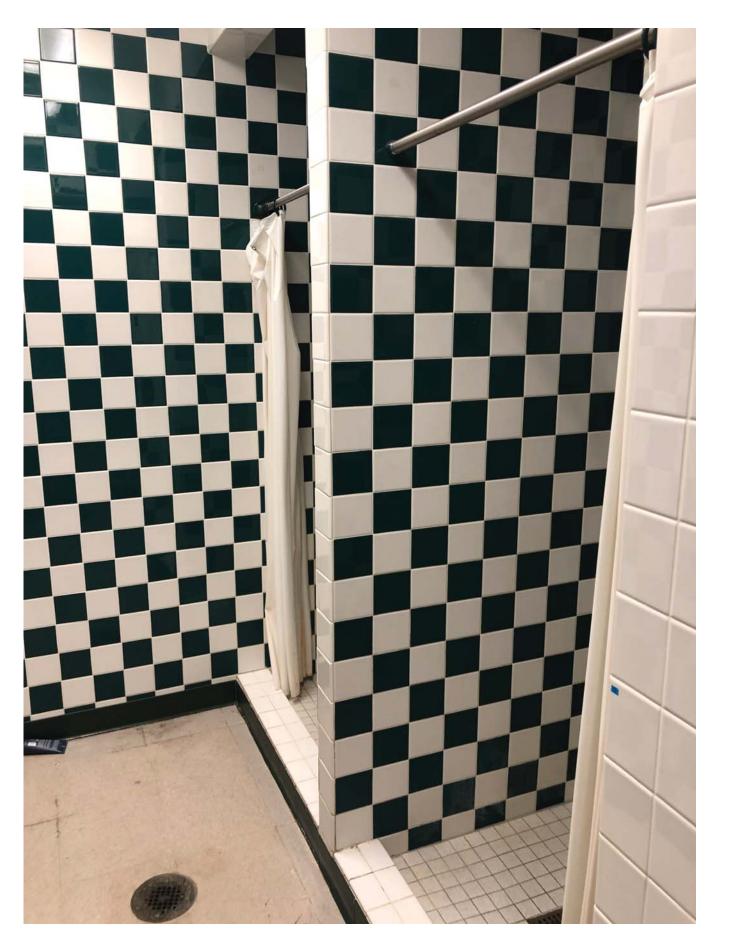
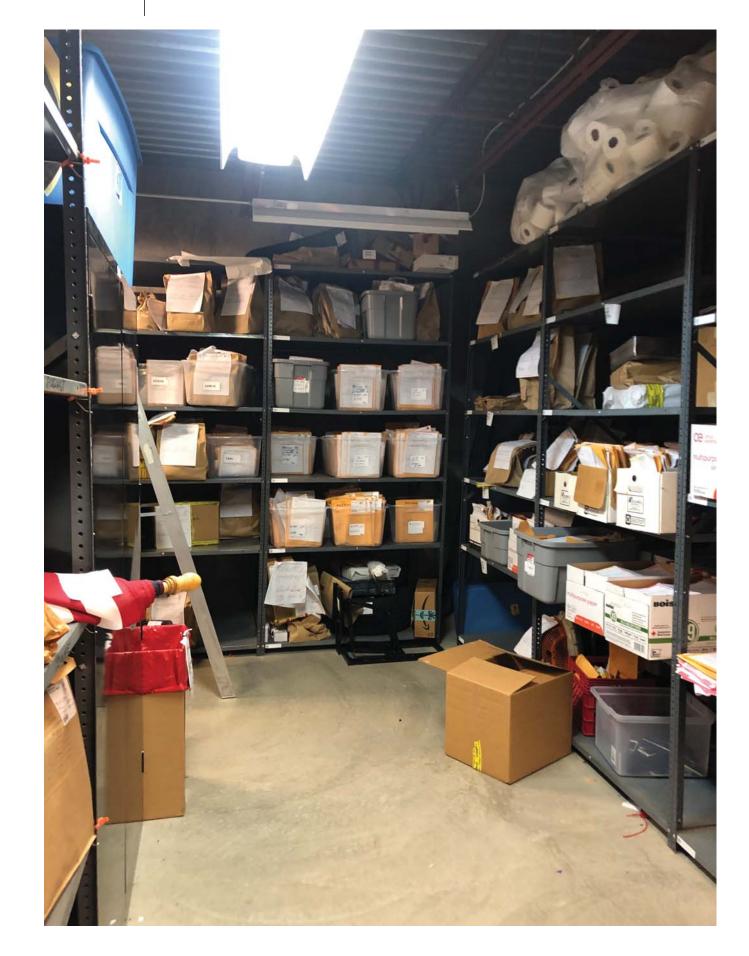
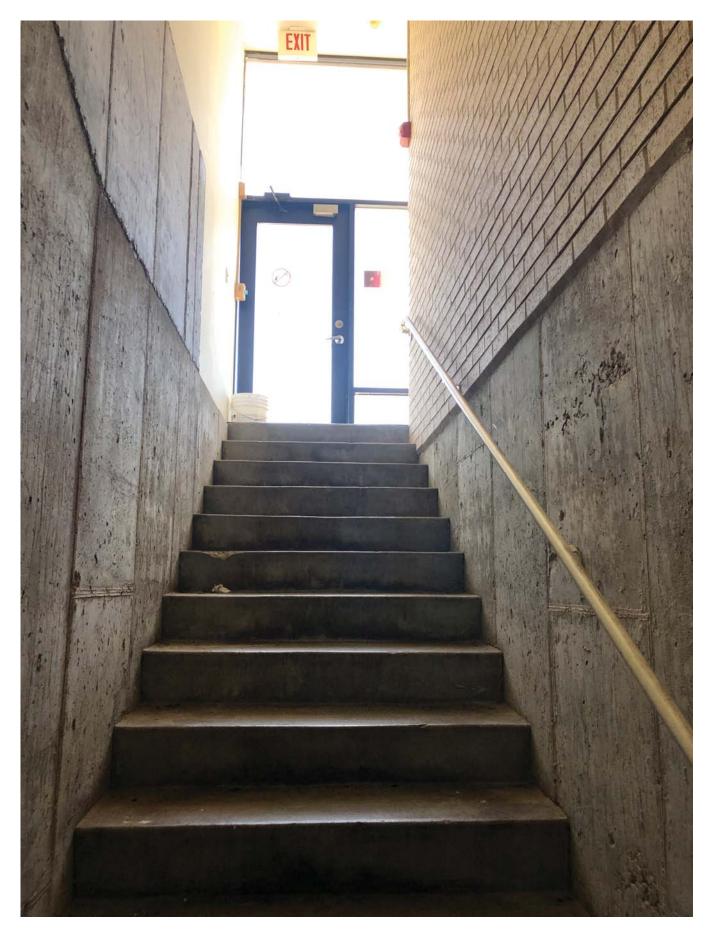
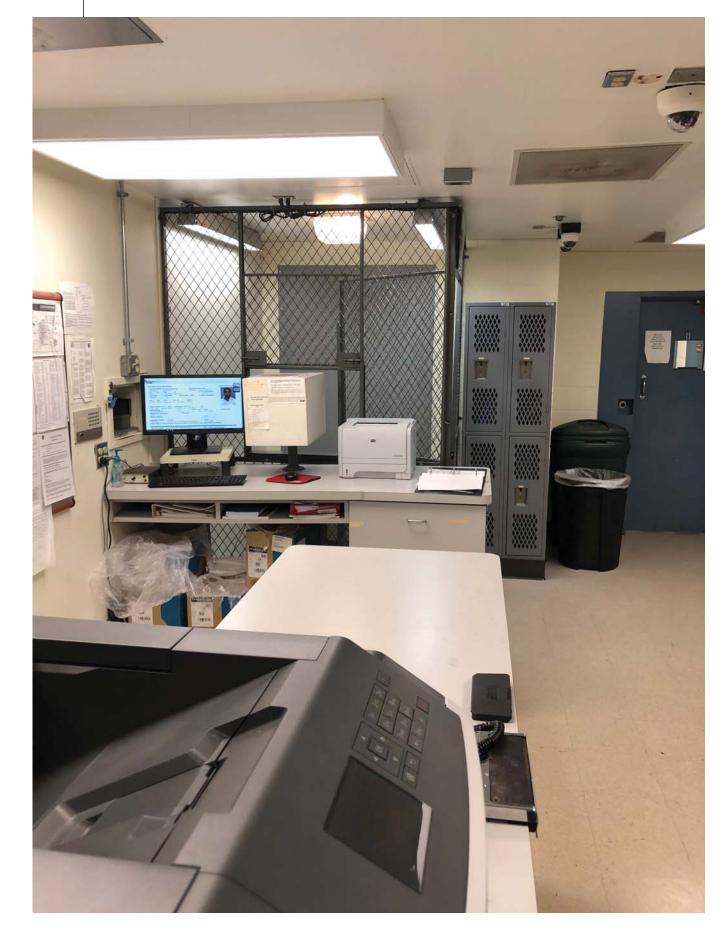
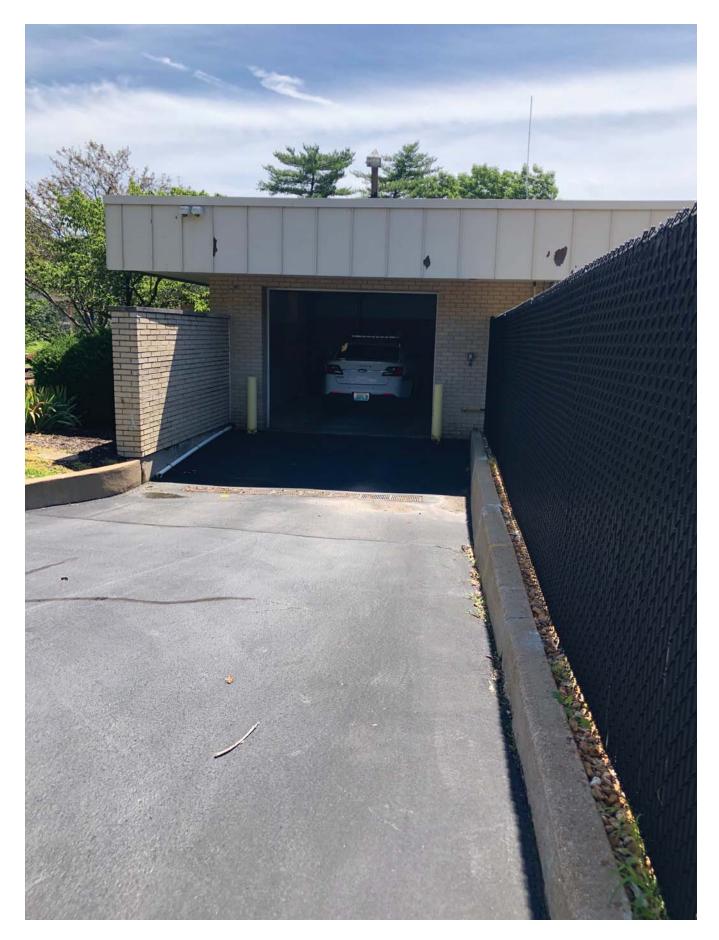
Roof consists of Copper Metal Panel & Flat Modified Multiple failing repairs and blisters, Improper Fasteners, Water Ponding Recommendation to replace copper roof and retrofit new flat modified roof

Windows are poorly insulated

Some minor cracking appears at foundation wall

Water infiltration at exterior doors

South "solarium" producing extreme heat gain and producing high humidity conditions

Many level changes occur throughout the facility with no elevator to lower level Interior partition layout does not allow for space needs of individual departments Narrow Corridors, locker room lockers not adequate for duty gear

Code Compliance - ADA, Life Safety, Storm Shelter requirements No current storm shelter or area of refuge per code No ADA access to lower level(s)

Not designed to withstand high wind event

Not designed to withstand seismic event

Ponding at doorways and entry points

Ponding water occurs in parking lot & site drainage issue on south side

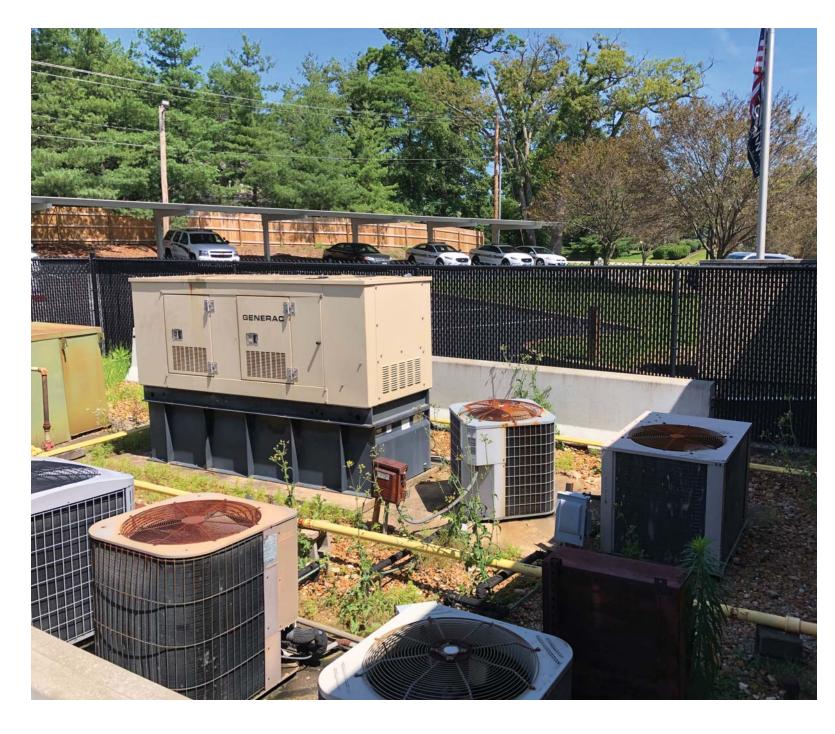
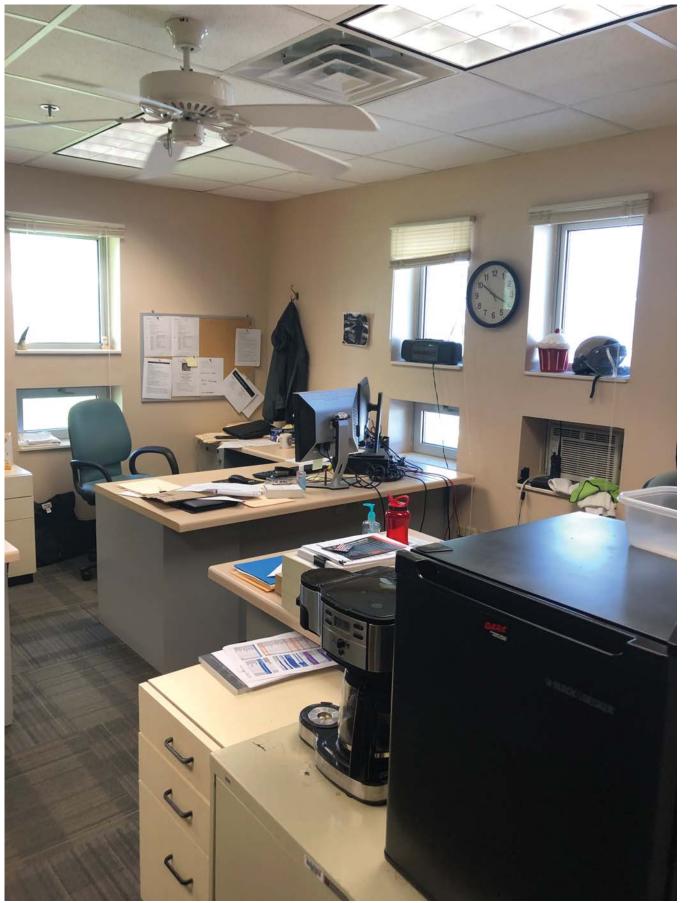
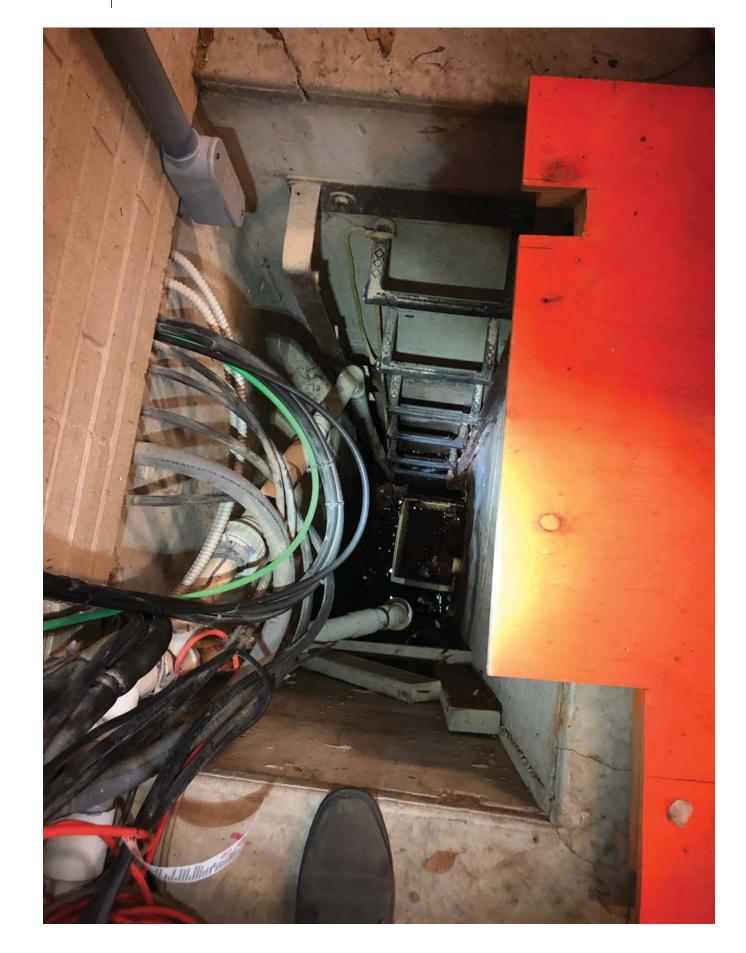
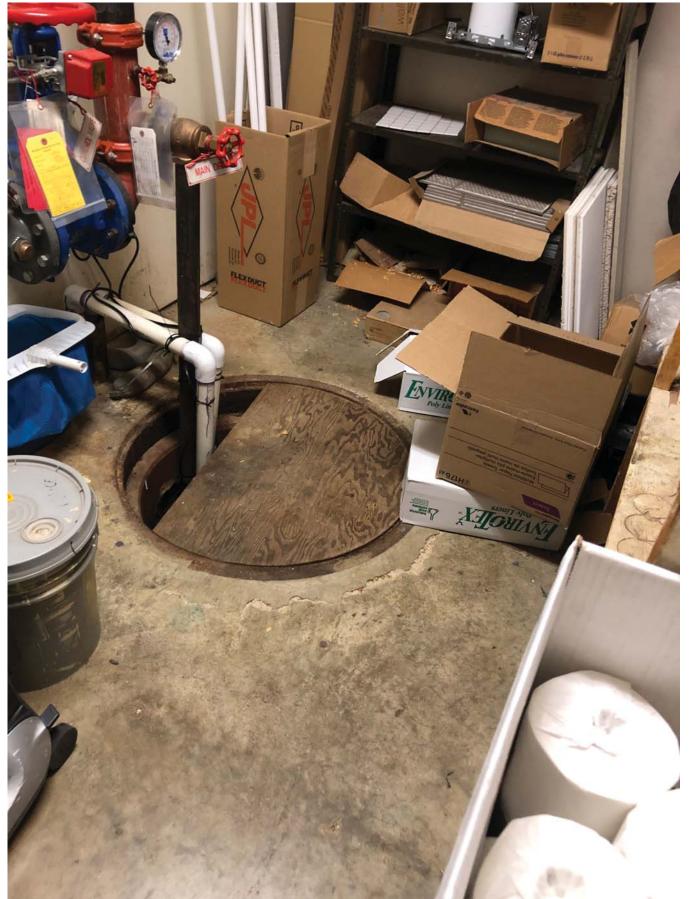
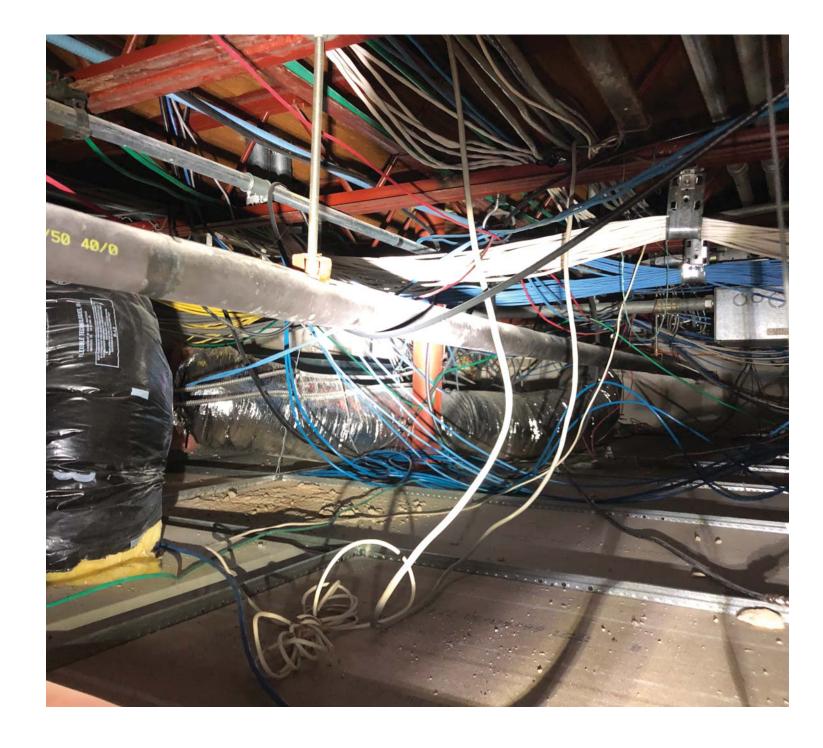
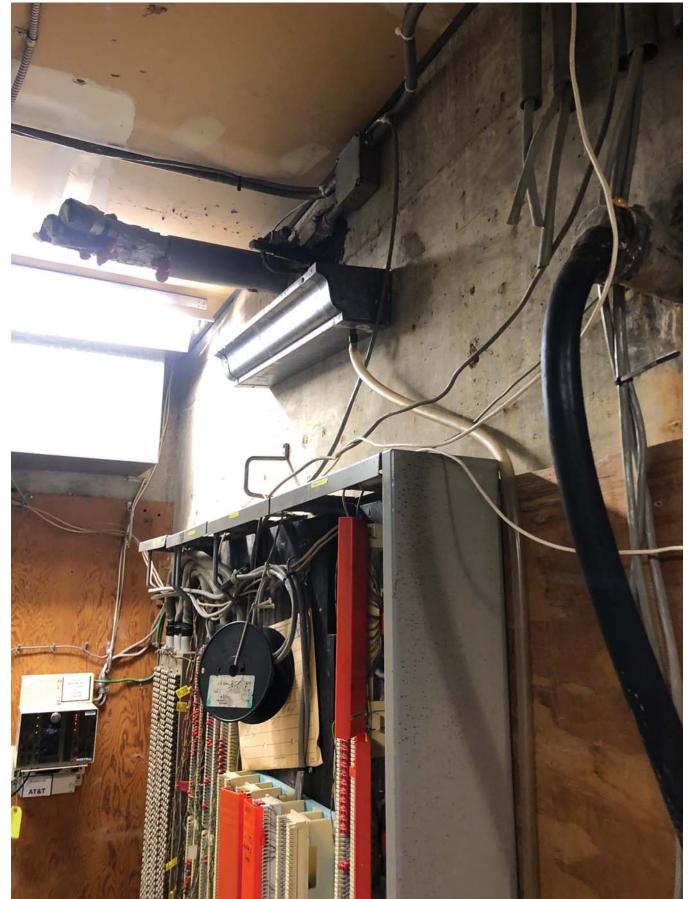
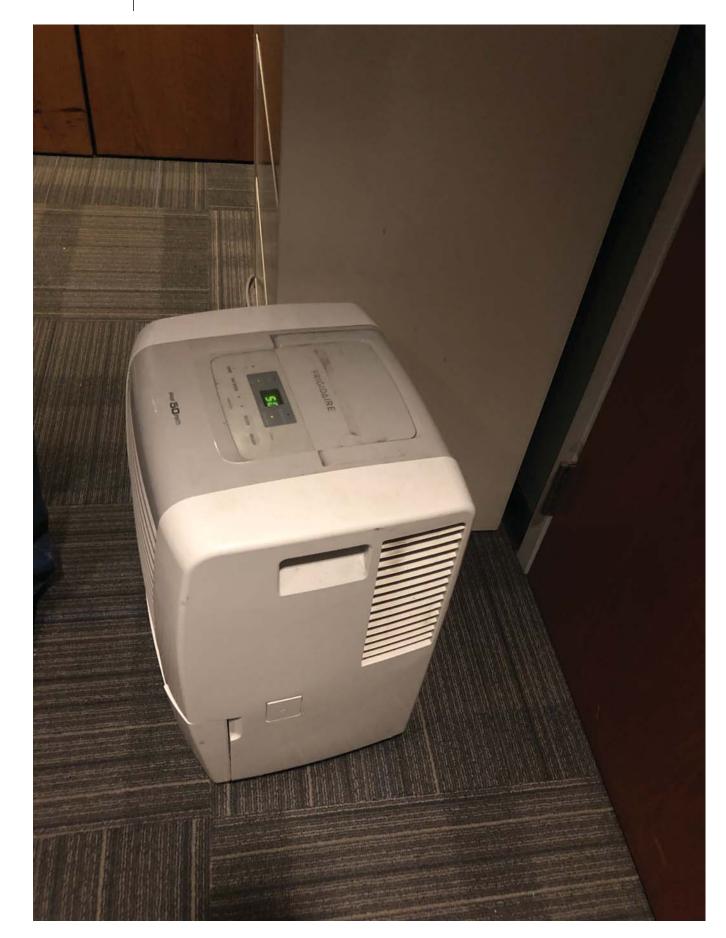
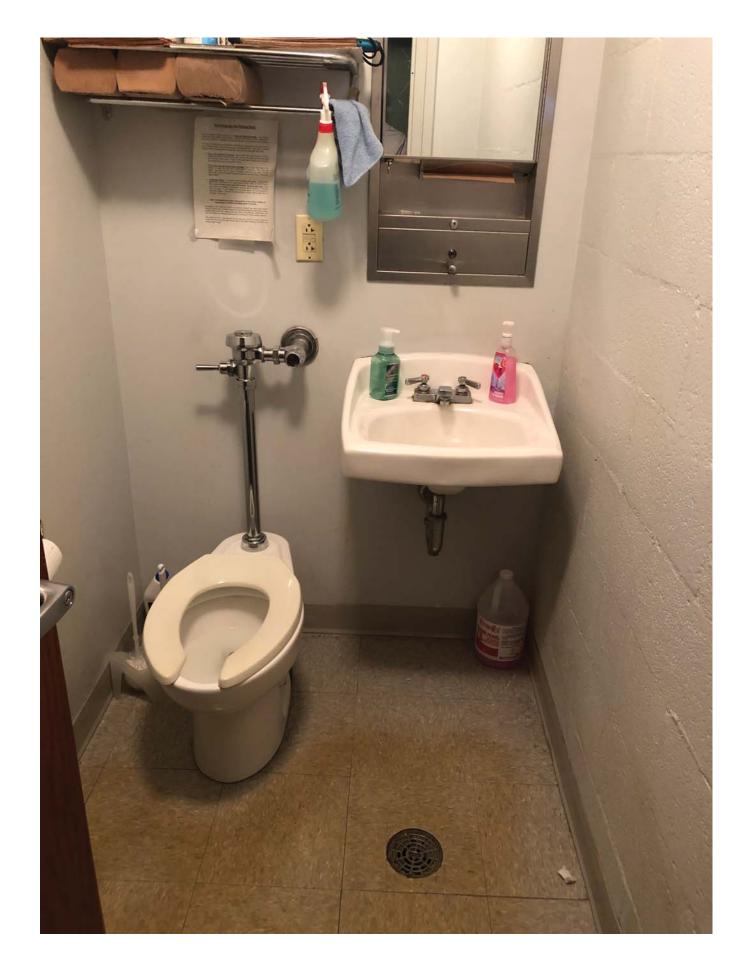
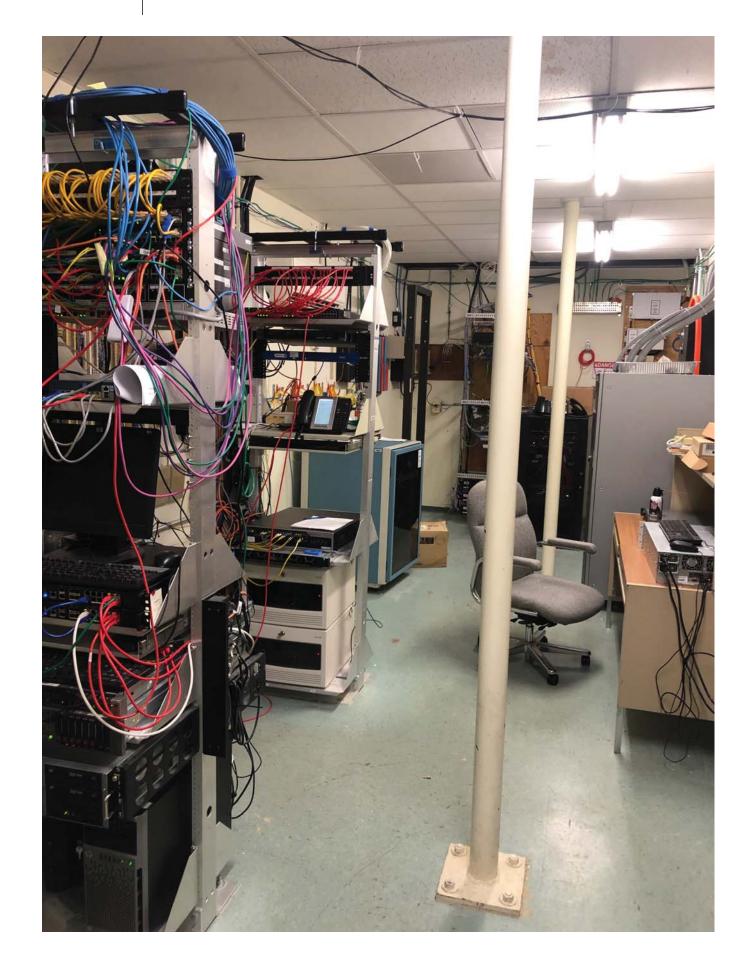
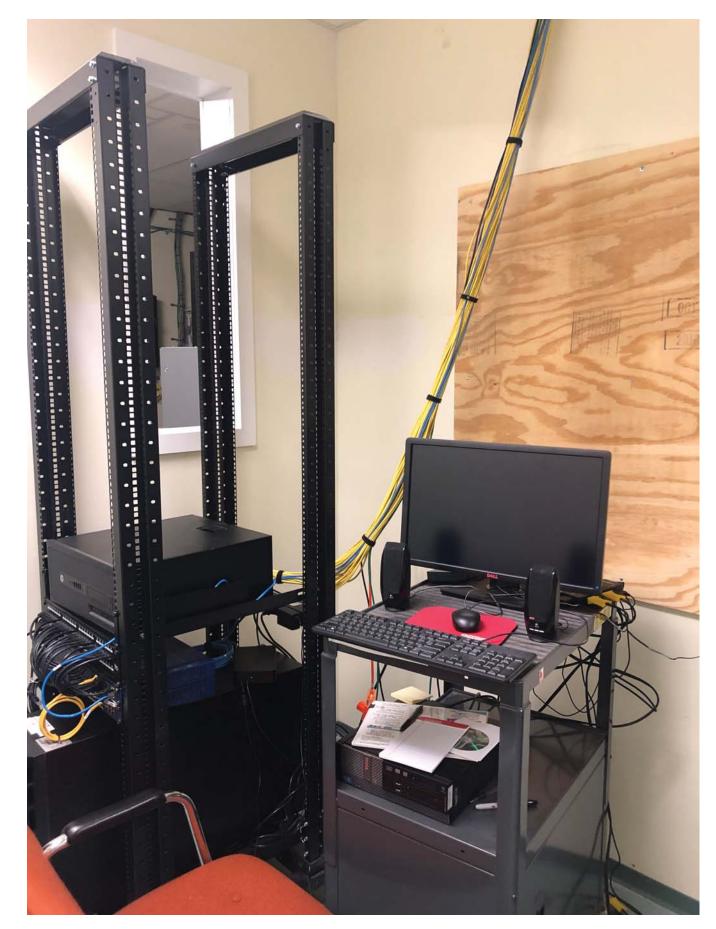
The building is operating under two different separate HVAC systems - rooftop and split systems

The three rooftop units lack proper zoning

Ductwork is disconnected in areas

No proper ventilation exists at lab processing, evidence storage, and gun cleaning areas

The existing RTU's are past their designed lifespan

Lighting is a combination of inefficient fluorescent troffers, compact fluorescent, and HID fixtures No occupancy sensors or lighting controls exist

Communication and Electrical infrastructure and utilities enter the facility within an active sump pit in the sally port - this area sees water on a constant basis

Sum Pit locations interfere with utility infrastructure Plumbing fixtures need replacing Hot Water Heater and Pump is past its designed lifespan

No proper fire suppression system in armory, evidence processing and storage rooms Parts of the building do not appear to have proper coverage by overhead sprinkler system
