City of Ballwin

April 2022

1 Introduction

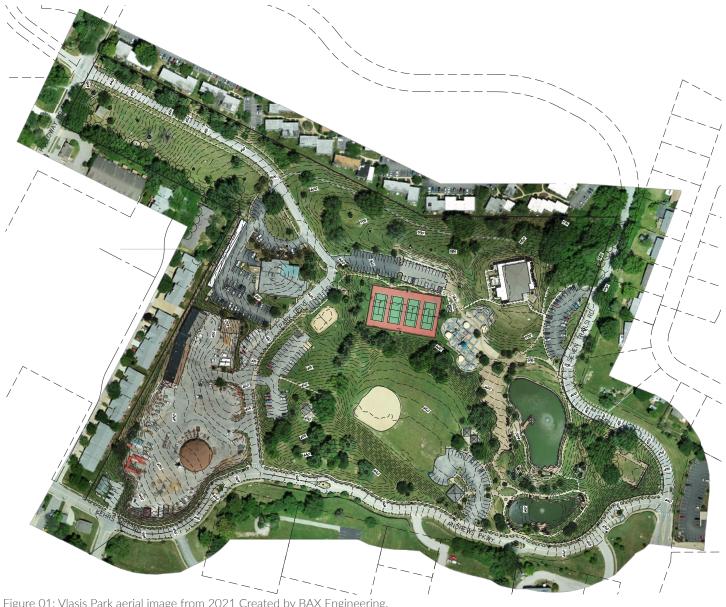
Figure 01: Vlasis Park aerial image from 2021 Created by BAX Engineering.

and improved to become the park that it is today. Aerial photography over the past 65 years shows how the vehicular circulation throughout the park has changed as new amenities such as the ball field, playground, and ponds were developed. For the most part, Vlasis Park has remained in its current configuration since the early 2000's. After the playground was built, cross-site vehicular access was removed entirely and limited to the perimeter roads.

Figure 01: Survey by BAX Engineering.

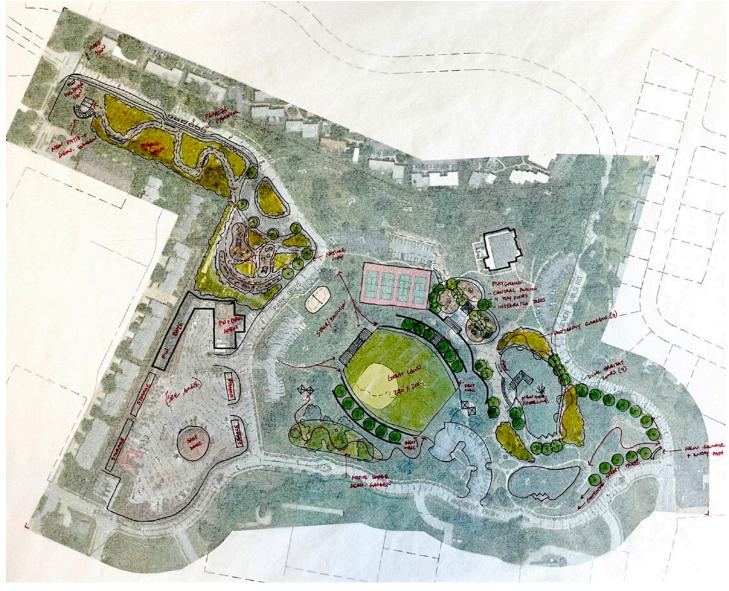
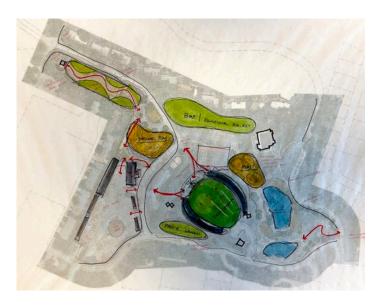
Figure 14: Concept design sketches developed for Vlasis Park.

A clear set of goals and objectives were developed based on community input, as well as the site analysis conducted by the design team. Concept designs began in the Fall of 2021 and were guided by these goals. Two different concept designs were presented to the public at an open house event where additional feedback and comments were received. Following the public meeting, the design team refined and combined these concepts into one final master plan concept.

Figure 14: Images by Jordan Wilkinson.

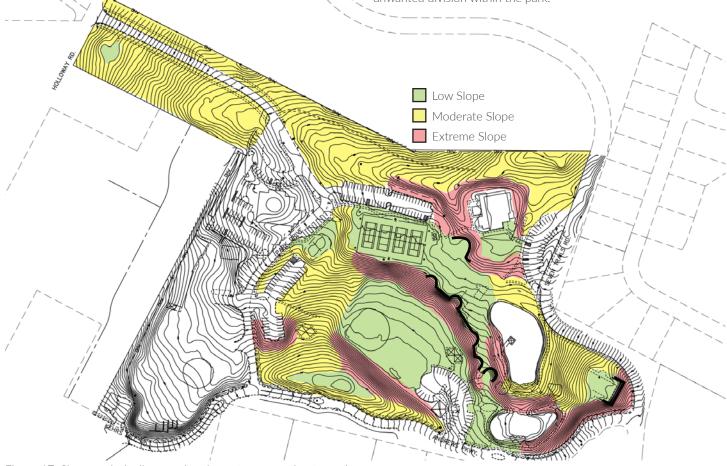
Figure 17: Slope analysis diagram showing extreme, moderate, and low slopes.

The steep grades found in Vlasis Park are some of the most challenging physical features of the site. The park slopes generally from the southwest down to the northeast. Elevations range from 655 ft at the highest point above the Public Works facility, down to 574 ft at the lowest point behind the Government Center. Development on the site throughout the years has leveled out terraces with the playground and tennis courts at an elevation around 600 ft. The baseball field and upper parking lot are both perched up at a higher elevation of 621 ft., and Andrews Parkway borders the southern edge of the park with undulating elevations ranging from 640-655 ft. This creates two large steep slopes bisecting the park with 3:1 grades. From a spatial planning perspective these topographical features provide the greatest challenge for Vlasis Park - limiting

Figure 17: Image by Lawrence Group.

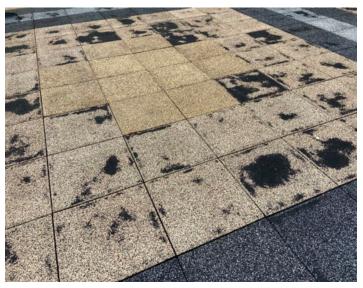
Figure 18: Safety surface tiles are in disrepair and require replacement.

The centrally-located playground at Vlasis Park is a huge draw for visitors. Its large size and variety of play features provide a wealth of play options for children ages 2-12. Constructed in 2003, the playground is starting to show its age and this is most-evident with the degradation seen on the safety surface tiles. Keeping up with repairs to the structures has become a challenge in recent years due to unavailable and discontinued parts. A splash pad was once a beloved feature of the play area, but unfortunately it currently remains non-operational.

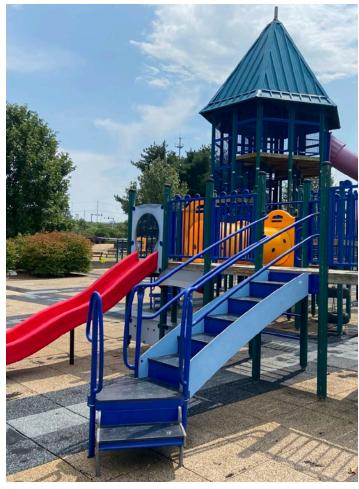
Figure 19: Existing playground structures are greatly enjoyed by the community but are outdated and require ongoing maintenance.

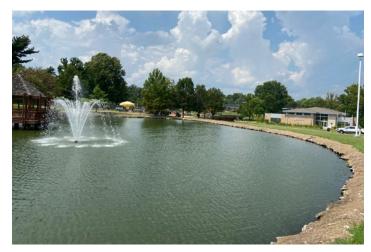
Figure 20: The lower pond showing the edge condition and fountain.

The two ponds at Vlasis Park are a beautiful focal point for the park. A smaller upper pond spills into the larger lower pond, which features a covered deck that reaches towards the middle of the pond. Additionally, each pond features a fountain for aeration and a small deck at the southern ends of the ponds. The decks and railings are constructed from wood, and are showing signs of deterioration. The half-acre lower pond is also a registered with the Missouri Department of Conservation and is stocked with 100 lbs of fish each month. The shoreline of both ponds is uninviting, and consists of small rip-rap style stone anchored in placed and topped with concrete. From time to time both ponds harbor excessive algae growth with the problem being worse on the upper pond. It is anticipated that both ponds need to be dredged to remove years of sediment input.

The existing ponds are a beloved amenity within the park and the plan is to preserve them for future generations. The existing pond edges are deteriorating and unsightly. Improvements include a new clean edge with aquatic benches to be planted with emergent wetland plants. A new dock relocated closer to the main entry walk will allow visitors more space and easier access for fishing in the lower pond.

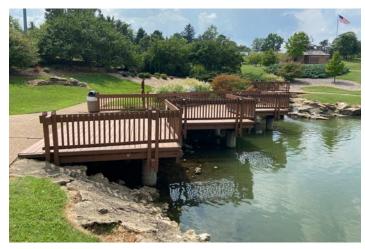
Figure 21: The decks on the south end of the lower pond are used by visitors for fishing and other activities but are deteriorating and require improvement or replacement.

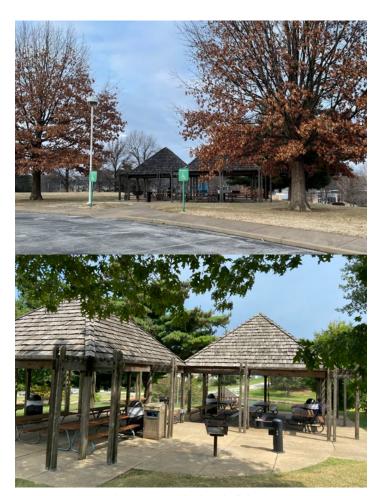
Figure 24: The pavilions east of the baseball field.

There are two clusters of pavilions at Vlasis Park on the upper half of the site. Each pavilion area features two covered structures measuring roughly 21'x21' for a total of four structures. The pavilions are of wood construction with wood shingle roofs and pergola-like extensions to allow filtered sunlight through. The patio spaces around these pavilions each contain a grill station, picnic tables, and trash/recycling receptacles. The pavilions are lit and have electrical outlets. The pavilions east of the baseball field are easily accessible from the parking lot and larger restroom facility, while the other pavilions west of the baseball field are less accessible. While these custom pavilions are iconic to Vlasis Park and offer a unique aesthetic, their wood construction is aging and will need to be repaired or replaced in the near future.

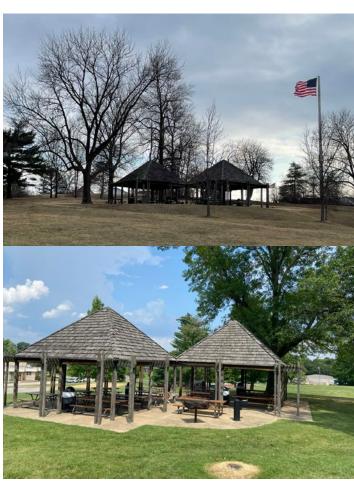
Figure 23: The pavilions west of the baseball field.

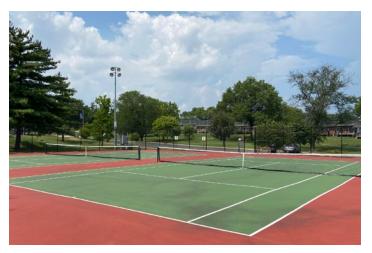
Figure 25: The lit tennis courts are a popular amenity at the park.

There are 4 tennis courts in the middle of Vlasis Park. These courts are adequately lit by 6 large light poles and were resurfaced in 2004. A full perimeter fence surrounds the courts, but there are no internal fences dividing the courts. There is visible cracking on the surface of the courts and it is suspected that an inadequate sub-base is allowing hydrostatic pressure to build up beneath the courts as they sit at the bottom of a slope.

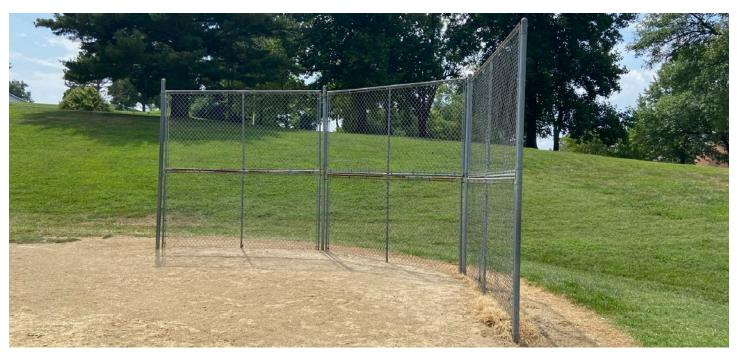
Figure 27: The centrally located baseball field lacks shade, lighting, and seating

There is one remaining baseball field at Vlasis Park – on the upper portion of the site. The field is oriented generally southwest to northeast and features a dirt infield and simple chain-link backstop. There are no designated lights to allow for nighttime games or practices. The turf in this area slopes toward the north-northeast with steeper slopes in the left field area of play. This area is also heavily trafficked during Ballwin

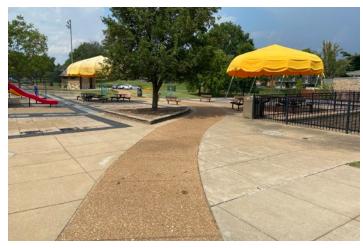
Figure 30: Concrete paths are mostly consistent throughout the park.

Vlasis Park offers a significant amount of sidewalks and paths. Most are concrete with the exception being the long asphalt connection at the northern end of the park. This asphalt trail is worn and weathered and needs to be replaced. Sidewalks along the perimeter roads allow park users to circumnavigate the park, but internal connections are lacking. The main paths connect the playground to the ponds through the center of the park, and continue with a loop around the ponds. There are several areas where paths exceed 5% slope.

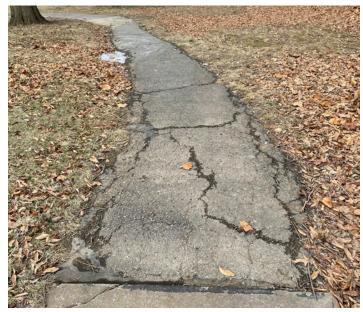
Figure 31: The asphalt path along the north side of the park creates a larger loop in the park but needs resurfacing.

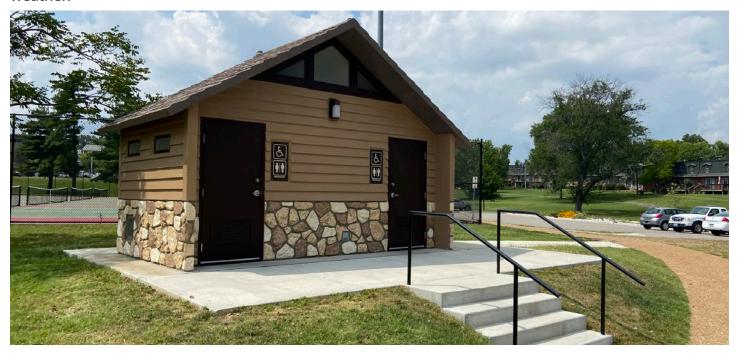
Figure 32: The new restroom facility provides easier access to park visitors utilizing the playground.

A large restroom building is sited adjacent to the upper parking lot off of Andrews Parkway. This structure was built in 2001 and is roughly 1,500 square feet in area. It served as the only restroom facility in Vlasis Park until 2020 when a pre-fabricated restroom structure was added west of the playground as recommended in the 2019 Parks & Rec. Master Plan. Both restrooms are closed and winterized each year during cold weather.

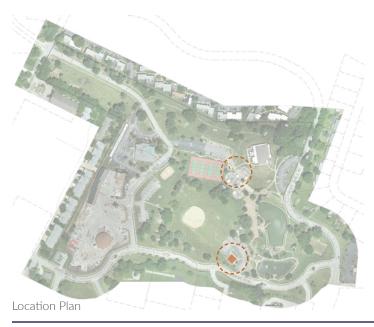
Figure 33: The larger restroom building adjacent to the parking area off Andrews Parkway.

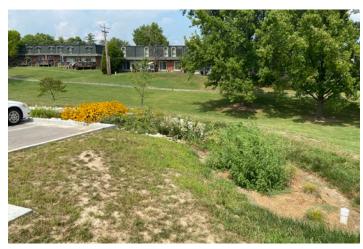
Figure 42: Bioretention cells help offset increased stormwater runoff created by impervious surfaces such as concrete or asphalt parking lots.

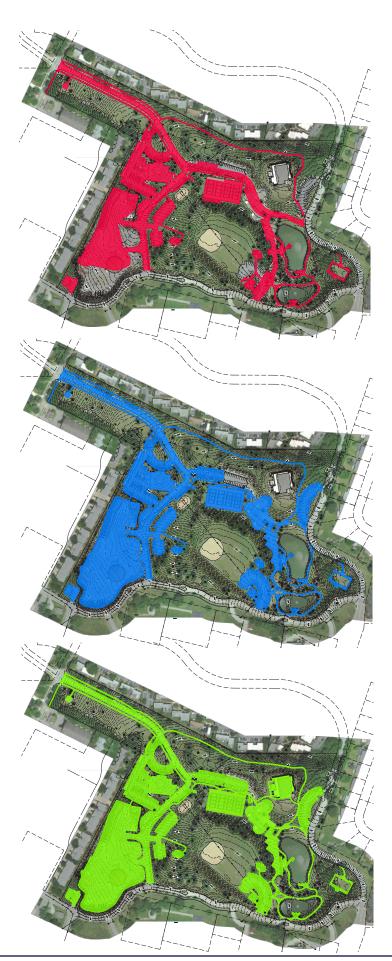
2021 Park Drainage Areas

2021	PARK	DRAINA	AGE 1	AREAS
IMPERV	IDUS A	REAS	10.67	AC
PERVIOUS AREAS			17.80 AC	
ΤΠΤΑΙ	ARFA		28.47	AC.

For water quality, MSD has established October 1, 2006 as the site conditions benchmark for tracking land disturbance. When total land disturbance exceeds 1 acre compared to the benchmark site conditions, all land disturbed after October 1, 2006 requires treatment for water quality. Water Quality consists of 1.) treatment to reduce pollutants and 2.) volume reduction. The intent of volume reduction is to mimic preexisting run off conditions by recharging the groundwater. The treatment features may be implemented in areas not disturbed so long as they are equivalent to the disturbed area. Due to a lack of historical design plans for the park, total area disturbed will be estimated using change in condition from pervious to impervious

Pervious Area	Impervious Area
	(ac)	(ac)
Year 2006 Condition	18.84	9.63
Year 2021 Condition	17.8	10.67

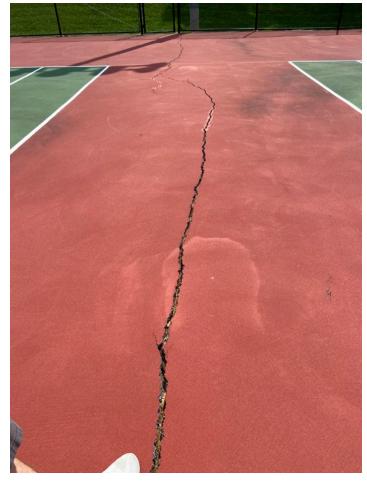
Figure 44: Large cracking is occurring on the tennis courts likely due to inadequate drainage south of the courts.

Minor erosion and drainage problems exist at various parts of the park. The swale along the left-field foul line of the baseball field shows signs of erosion and stays wet for longer periods. Likewise, the swale at the northern side of the park, which receives a large amount of sheet flow over the grassy area, shows signs of erosion and minor scouring. Finally, visible cracking on the surface of the tennis courts leads to an assumption that an inadequate sub-base is allowing hydrostatic pressure to build up beneath the courts as they sit at the bottom of the slope. One stormwater inlet sits adjacent to the southern side of the courts.

A bioswale or French drain should be installed at the bottom of the existing slope to intercept stormwater before it hits the tennis courts. This will allow the tennis court sub-base to freely drain and reduce surface cracking.

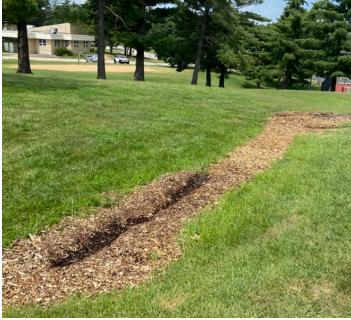
Figure 45: Drainage is channeled to the swale along the left-field foul line creating erosion issues.

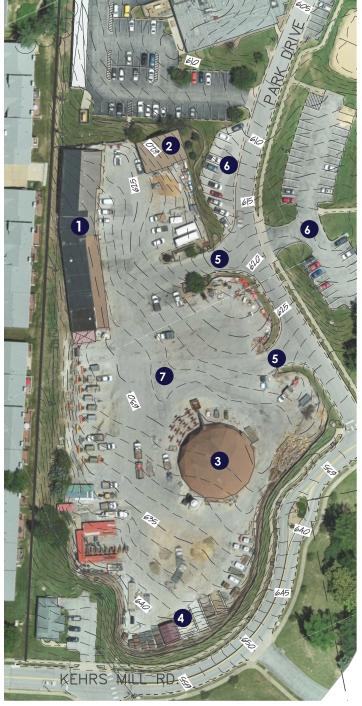
Legend 1 Main Public Works Building 2 Parks & Facilities Building 3 Salt Dome 4 Raw Materials Storage 5 Gated Access 6 Employee Parking

Figure 46: Public Works existing conditions.

The main building at the public works facility was constructed in the 1960's, while the 2,200 square foot parks & facilities building was built in 1984. The public works building is 10,500 square feet in size and is the center of operations for the department and its 33 employees. 5 Building Systems employees also use the northern portion of the building as their workshop. Between the 2 buildings there is a total of 8 work bays for maintaining and repairing equipment. Many of the vehicles are too large or tall to fit in these covered bays, and as such sit unprotected and exposed to the elements year-round. In total, the public works department has at 46 vehicles, 18 truck attachments, and 44 pieces of small equipment and trailers. The parks and recreation department has 8 vehicles, 3 trailers, and a sound stage/ bandwagon. The public works building also has limited storage space and lacks a central meeting space for its employees. Currently the department meets in one of their vehicle maintenance bays.

The main building is in poor condition, with a roof and back wall that both actively leak water into the spaces. The current setup for the salt brine operations does not have adequate water pressure and needs a new water pump that could also support their wash bay. Although there is no history of security issues on the site, outdoor lighting is extremely limited and leaves many dark spots at night.

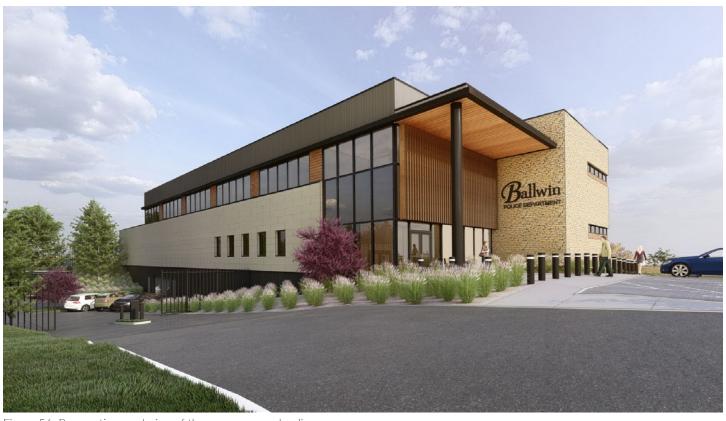
Figure 56: Perspective rendering of the new proposed police station. Design and rendering by JEMA.

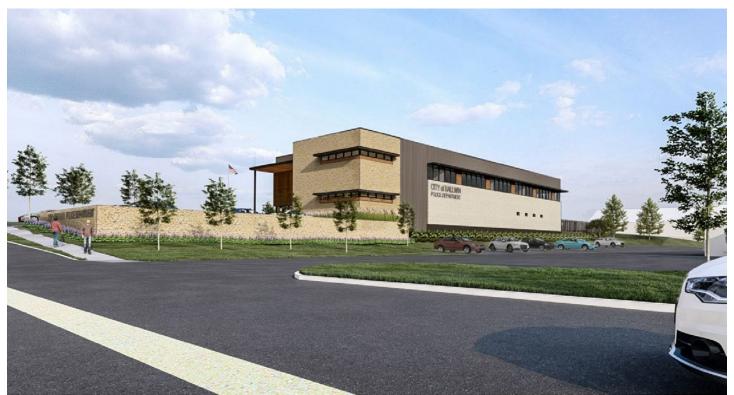
Figure 57: View from Ballpark Dr. of the new proposed police station. Design and rendering by JEMA.

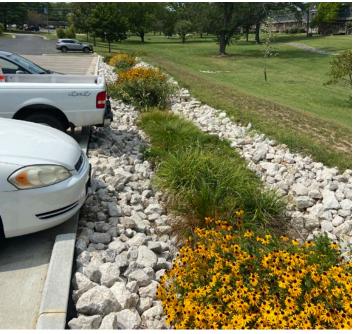
Figure 61: Planting with bioswales provide aesthetic value as well as functional purposes.

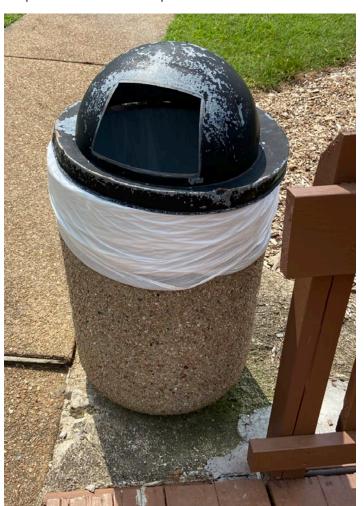
Figure 65: An exposed aggregate trash receptacle.

The site furnishings at Vlasis Park are dated, but reliable. Trash receptacles are either an exposed aggregate concrete or a web-coated expanded metal in green or black. Both options have a simple domed lid with removable liners. Picnic shelters have recycling receptacles made from a composite plastic material, as well as stationary charcoal grill stations. The picnic tables at the pavilions are a simple stained wood top over galvanized steel legs. Drinking fountains are modern and accessible in a black powdercoat. Park benches are steel framed with wooden slats on the seating surfaces and backs, matching the picnic tables. Light bollards around the ponds are an exposed aggregate finish matching the plaza and some of the trash receptacles. Overall the site furnishings are not very attractive, nor do they help define a sense of place for Vlasis Park.

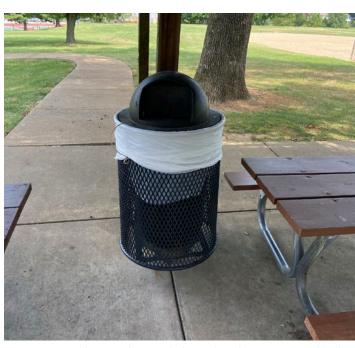
Figure 64: A web-coated expanded metal trash receptacle in black.

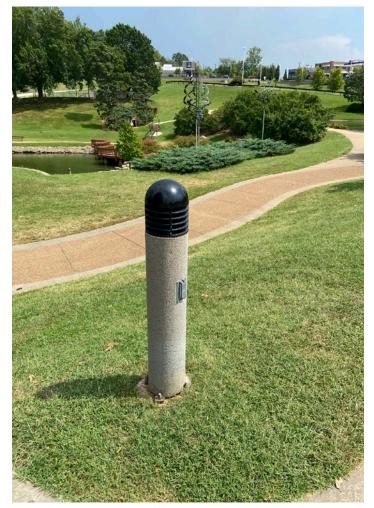
Figure 69: Light bollard with exposed aggregate finish.

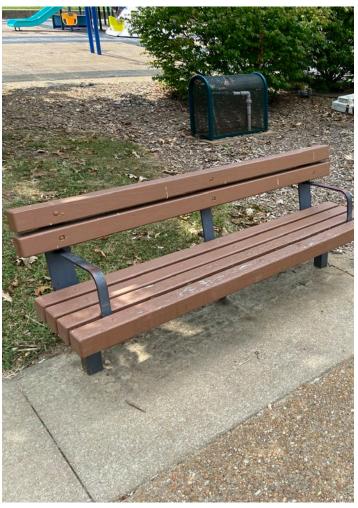
Figure 70: Typical bench with wood slats and metal base.

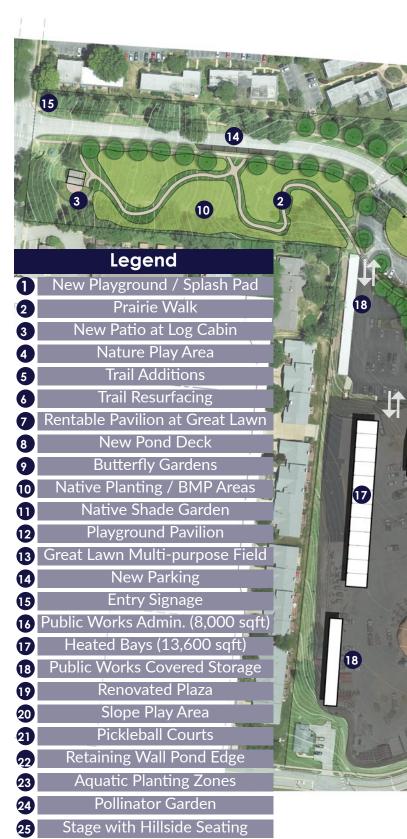
Figure 80: Final concept plan developed for Vlasis Park.

The final concept design for Vlasis Park is a hybrid of the 2 concepts developed for public feedback. Many of the features from concept 2 have been retained in the final design, with a few additional improvements from concept 1.

Natural landscape-oriented improvements including the prairie walk, shade garden, pollinator garden, and pond rehabilitation are vital components of this final design. A bioretention area will be needed in the central northern area of the site, and should be optimized to become another educational and interactive element to the park. Signage highlighting the stormwater functions, native plants, and hydrology should be incorporated.

Lastly, the plan for the public works facility is a combination of 2 concepts, with a split-level administration / office building fronting the street.

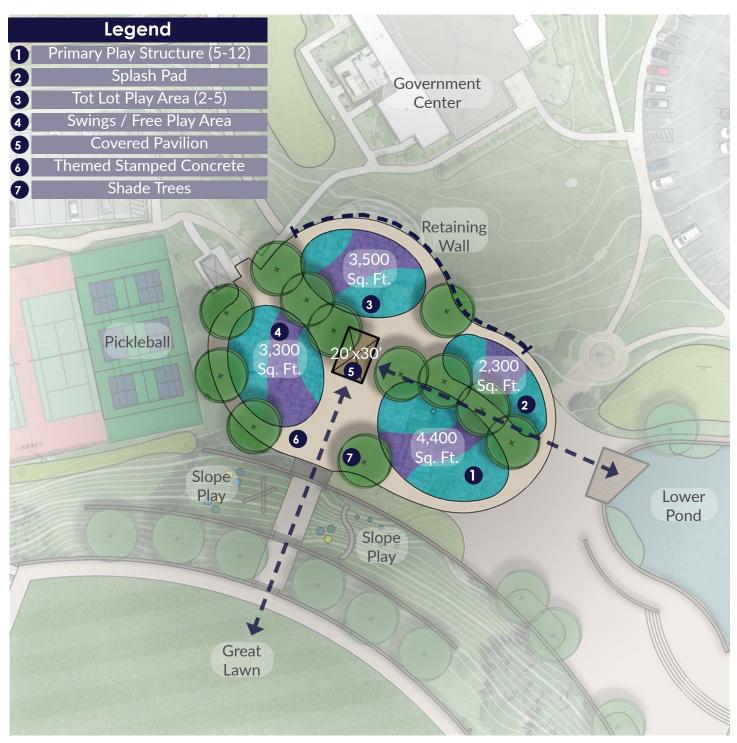
Figure 84: Sizing and framework layout for a new traditional playground space

An updated playground will be the centerpiece of the park, attracting both local and regional visitors and creating a destination at Vlasis Park. Play equipment will include custom-designed and standard play structures with various subareas including a tot lot (2-5 years), splash pad, pavilions for shade, play stages, and elevated play. The playground will also be designed with accessibility in mind, providing ADA accessible play equipment, multi-sensory engaging elements, and imaginative spaces for exploration and refuge alike.

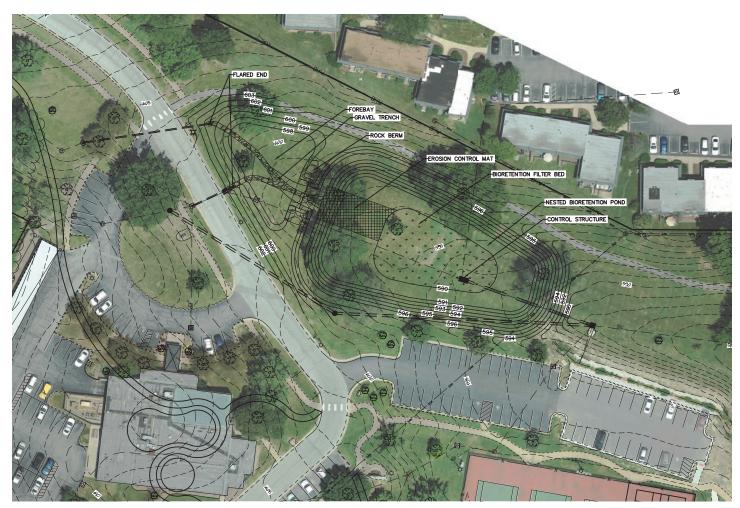
Figure 94: Proposed bioretention basin at the north end of the park.

Several areas were considered for conceptual improvements to satisfy detention, channel protection, and water quality requirements. The existing (lower) pond was considered for detention, however there is concern for the resulting highwater elevation relative to the existing perimeter improvements. A berm would be necessary to provide the required detention capacity and freeboard. Based on review of site analysis, a new basin would be most practical. An onsite nested bioretention basin with forebay, located at the north end of the park, will allow for requirements for detention, channel protection, water quality and flood protection to be satisfied within a single basin. The elevation of the bioretention floor will be 590.00 ft. See Exhibit A for conceptual layout plan of the nested bioretention basin.

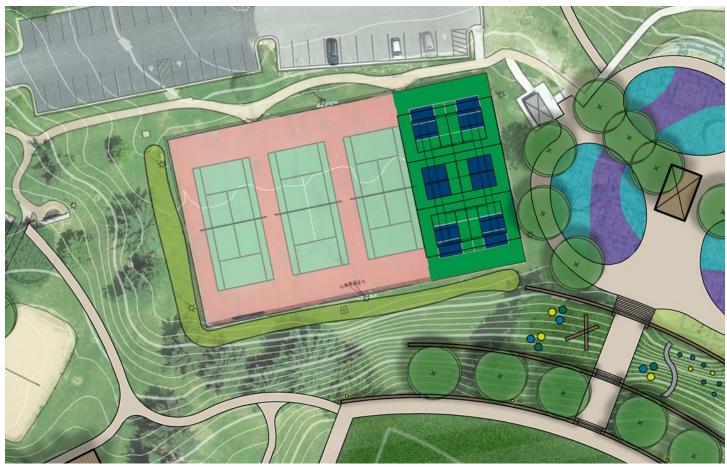
Figure 96: The proposed pickleball layout utilizes the area of the eastern most existing tennis ball court, and maximizes space.

Locating the new pickleball courts at this site will ensure close proximity to existing parking and restroom facilities. While the E-W orientation of the courts is not ideal, it maximizes the space and provides for a third court. If the courts were rotated to a N-S orientation, 1 whole court would be sacrificed in the design.

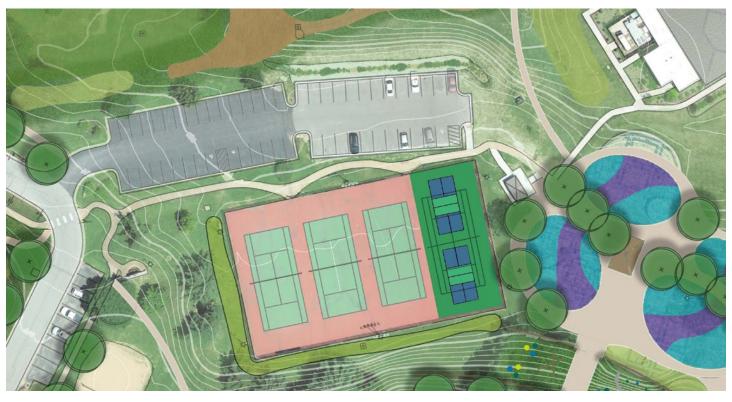
Figure 97: Alternative layout 1 creates an ideal orientation of the courts, but removes 1 of the pickleball courts.

Additional sites for pickle ball courts were explored in concept 1 at the previous location of the old horseshoe pits. A number of factors impeded the use of this space for courts, such as tree removal and the grade changes to create off-street parking. This option also would have increased impervious surface and required additional stormwater treatment.

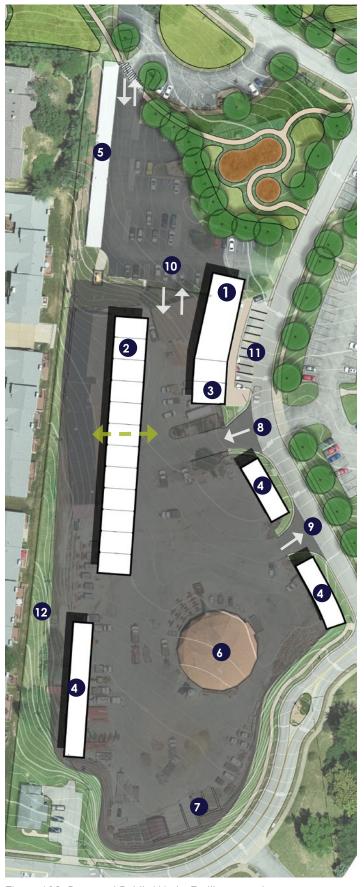
Figure 102: Proposed Public Works Facility upgrades

- 5 offices (750 Sq. Ft. total)
- Men's and Women's locker rooms / showers (1,200 Sq. Ft. total)
- Cafeteria for 33 people (500 Sq. Ft.)
- Conference Room for 40 people (900 Sq. Ft.)
- Heated bays are 25'x40' at 16' height
- Includes 1 wash bay

In the area of the current police station the design includes a new 4,500 sq. ft. office building for the public works department. This increases the department's footprint, which would also include an additional 12,000 sq. ft. of pull-through heated bays and multiple covered storage structures. Concept 1 also includes trail additions and resurfacing throughout the park. A variety of native plant areas are planned to function as required BMP areas to help clean and slow stormwater runoff in the park.

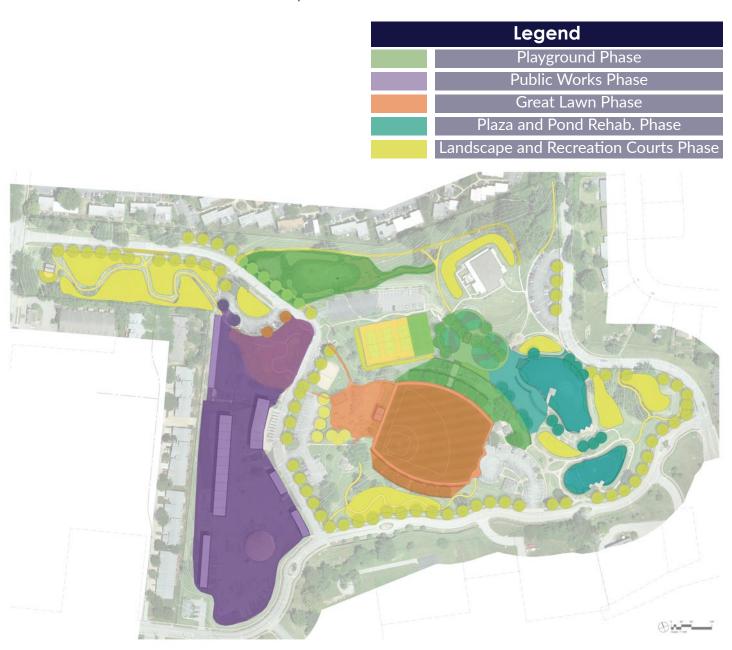
Figure 104: Overall phasing plan.

The master plan can be broken down into 5 separate phases. These phases were developed in an effort to balance anticipated costs, while also considering constructibility logistics, and prioritization. For example, items that came up in high demand in survey responses and public comments are included in earlier phases. Related improvements are grouped together as well as amenities that are in the same area of the park.

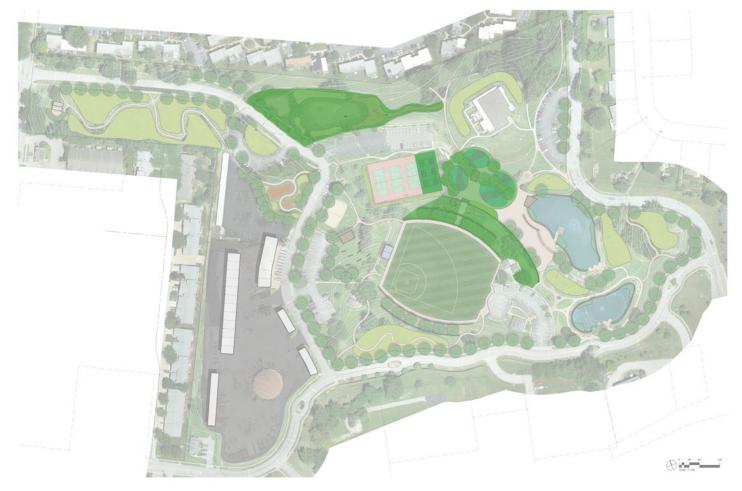
Figure 105: Playground phase plan.

Proposed Improvments	Quantity	Unit	Cost Opinion
a)	Pickleball striping, nets, court repair	1	EA	\$5,000
Phase	Traditional Playground	27,000	SF	\$550,000
	Hillside Slope Play Area	5,000	SF	\$100,000
pun	New Pavilion at Playground	600	SF	\$55,000
gro	Splash Pad	1	LS	\$35,000
Playgrou	Stormwater BMP's	1	LS	\$150,000
_	Retaining Walls & Central Stair Connection	410	LF	\$120,000

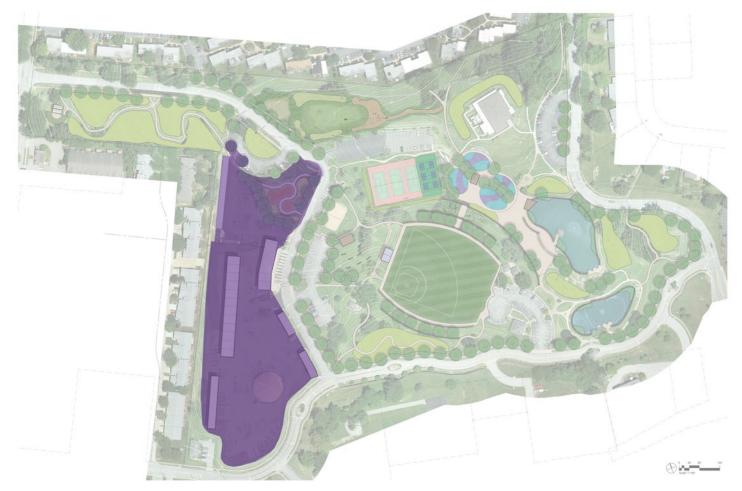
Figure 106: Public works phase plan.

Propo	sed Improvments	Quantity	Unit	Cost Opinion
Police Department Dem	olition	1	LS	\$100,000
Covered Storage		8,000	SF	\$240,000
Heated Bays		14,000	SF	\$1,200,000
Administration Building		8,000	SF	\$2,400,000
New north-south conne	ction	1	LS	\$75,000
Demolition of existing P	arks & Facilities Building	1	LS	\$25,000
Perimeter Screenwall &	Planting	1,400	LF	\$80,000

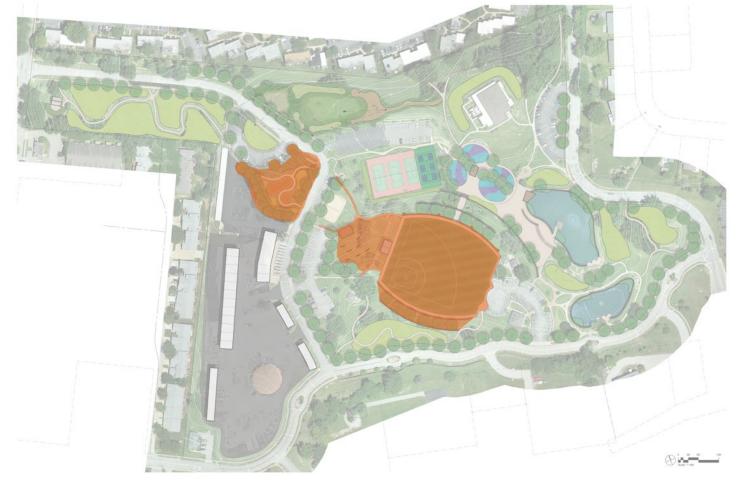
Figure 107: Great lawn phase plan.

Proposed Improvments	Quantity	Unit	Cost Opinion
	Nature Play Area	17,000	SF	\$155,000
Se	Multi-Purpose Field	56,000	SF	\$330,000
Phase	Cedar Pavilion (pre-fabricated)	800	SF	\$90,000
Lawn	Stage	1,500	SF	\$160,000
	Boulder Outcroppings	100	LF	\$30,000
Great	Seatwalls	1,150	LF	\$75,000
Ğ	Mobile backstop for ball field	1	EA	\$3,000
	Lighting	8	EA	\$30,000

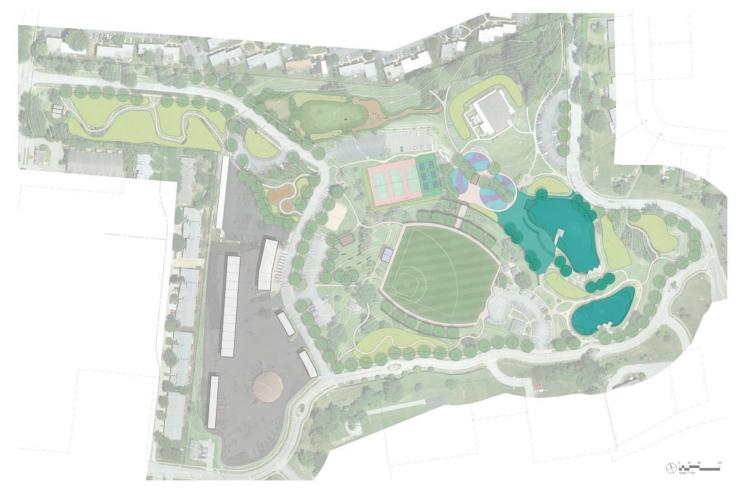
Figure 108: Plaza and pond rehabilitation phase plan.

Proposed Improvments	Quantity	Unit	Cost Opinion
	Central Plaza Renovation	19,000	SF	\$190,000
Rehab.	Electrical Infrastructure Upgrades	1	LS	\$200,000
Rek	Concrete Sidewalks	9,900	SF	\$75,000
Pond Phase	Asphalt Paths	4,400	SF	\$27,000
	Retaining Wall Perimeter	650	LF	\$175,000
a S	Dredging	41,000	SF	\$95,000
Plaza	Deck Platform	750	SF	\$48,000
ш.	Aquatic Benches & Emergent Plantings	5,000	SF	\$45,000

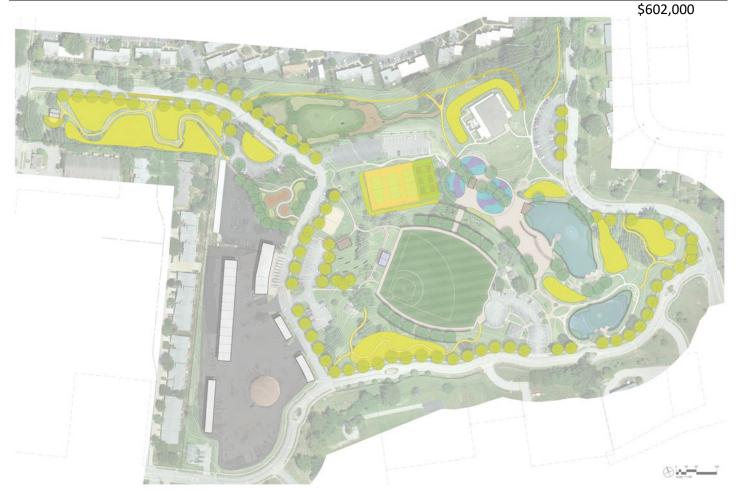
Figure 109: Landscape and recreation courts phase plan.

Landscape & Recreation Courts Phase Cost Opinion:
